M85 An analysis of reliability

M85 - an analysis of reliability

This report presents a detailed analysis of M85 performance based on survey and clearance of M85 contaminated sites in southern Lebanon and on detailed analysis of M85 performance under test conditions, leading to the following conclusions:

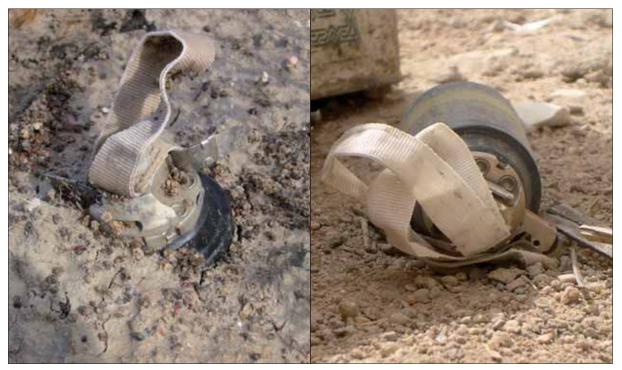
Figure 4: M85 dud in Basra. Photo: DanChurchAid archives Figure 5: M85 dud in Basra. Photo: Bonnie Docherty, HRW

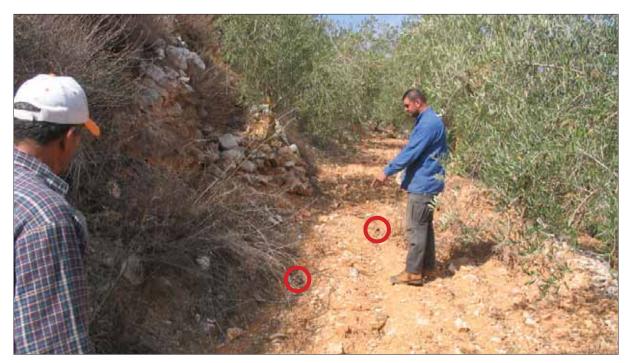
Figure 6: An olive farmer at site CBU 808 in Blida standing next to two M85 duds. This site was visited in October 2006 as an EOD team from BACTEC had just arrived. They identified six M85 duds just along a road when they started to move into this area. A total of 26 M85 duds were removed by the BACTEC EOD team that day and the day after. Photo: Hassan Al Ali/MACC SL.

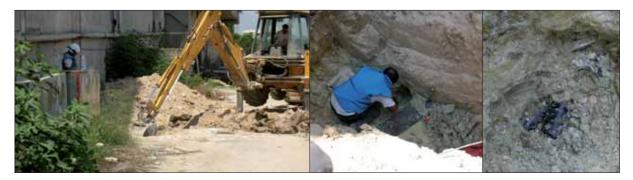
Figures 7-9: On 26 June 2007 Swedish Rescue Services Agency (SRSA) were called to a site in Deir Qanoun Al Nahr to investigate a complete failure of a 155 mm cargo projectile. The projectile's entry hole was just by the back wall of a block of flats. Upon arrival, they found three M85 duds in the middle of the road between the block of flats and an orange grove. The entry hole was excavated and M85 bomblets were found at various depths along the entire entry hole, but most of them just before the projectile casing, which was a CL3013-E1. No bomblets remained inside the projectile. Photos: Robert Ericsson/SRSA

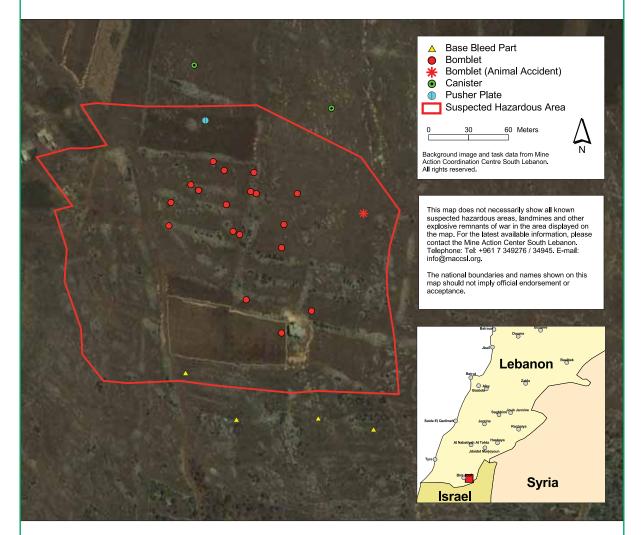
Failure rate analysis: At least 9.6%

The site CBU 804 consists of stony/hard soil. The owner had not been able to use the land since the conflict. A total of 7 M85 duds were found during the research clearance, one of which was buried at 5 cm depth. Earlier, a total of 11 M85 duds had been destroyed by Lebanese Armed Forces (LAF) at sites marked by the landowner and/or MACC SL and for which the exact positions were established. According to LAF they cleared an additional three duds, but these have not been included in the findings since their position and existence could not be verified. The landowner also pointed out a spot where a dud had exploded and killed a goat, and this dud was included in the failure rate calculation.

Two empty projectiles were located at the expected range from the footprint/strike area. The research concluded that the duds found in CBU 804 were the result of a maximum of four normally deployed base-bleed projectiles (with 49 bomblets each). This means that a total of at the most 196 bomblets were fired into the area. With at least 19 duds this means a failure rate of at least 9.6%.

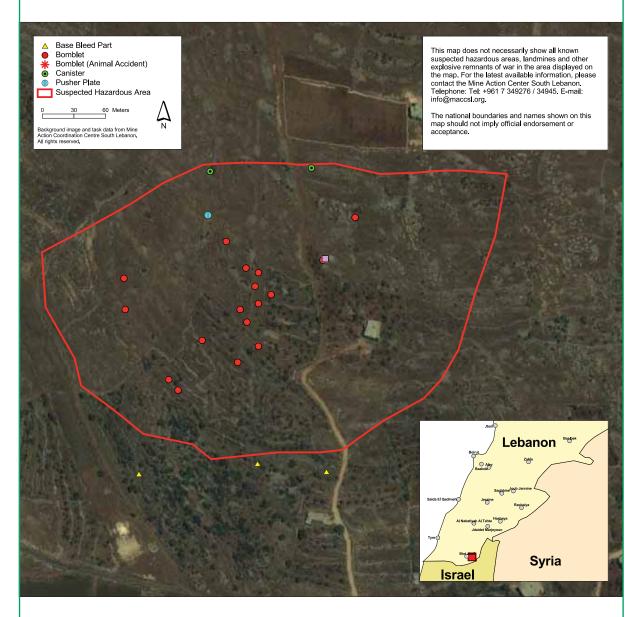
No. of M85 duds found: 17 Failure Rate Analysis: 11.5%

This area consists of olive groves and cactus located around a house. The ground is a mix of stony/hard soil and farmland. The owner had not been able to use the land since the conflict. The research clearance team found 6 M85 duds. In addition 11 marked M85 duds which had previously been visually inspected by the researchers for this report had been removed by LAF from positions that could be accurately established. Two empty projectiles and three base-bleed elements were found. In addition, one projectile was found at 1.5 m depth that had failed to open. The research concluded that three base-bleed projectiles (with 49 bomblets each) had been normally deployed in the area, resulting in 17 duds and a failure rate of 11.5%. The research found that one additional projectile had failed to open but this was not utilised in the calculation of bomblet failure rates. It cannot be ruled out that one of the 17 duds had been ejected from this latter failed projectile after it crashed into the ground. If this one dud is excluded from the analysis, then the failure rate is 10.9%.

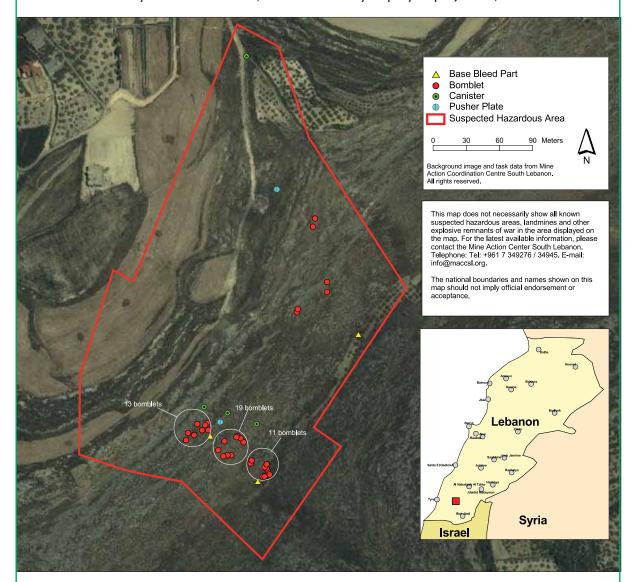
Failure Rate Analysis: 12.2% (for one normally deployed projectile)

The site CBU 601 Alpha is located in a steep valley covered with grass and bushes and with olive trees at the bottom. The ground is mostly stony/hard soil. The analysis concluded that a total of four base-bleed projectiles had been fired into this area, containing a total of 196 bomblets. The number of M85 duds found by the research clearance team in the area was a total of 49.

However, three of the projectiles did not deploy normally. They either crashed to the ground unopened and then ejected their payload, or they opened at a very low height. At least one of these three projectiles must have opened at only approximately 10 meters altitude, as there was a clearly identifiable footprint of only 3 m in diameter. The footprints from the abnormal deployments show that most of the bomblets did indeed detonate as intended (the flight time required for arming of M85 bomblets is very short). Nevertheless, the 43 duds that resulted from the three projectiles that did not deploy normally have been disregard in the failure rate analysis.

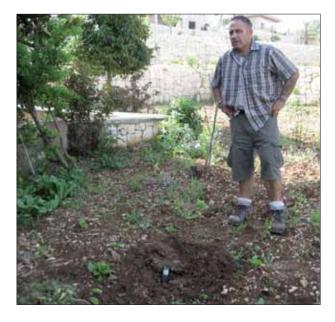
Figure 10: MACC SL Operations Officer Albert Philip investigating the scene of an accident where a woman was killed on 5 April 2007 when she disturbed a buried M85 dud while working in her garden in the village Aynata. Pieces of M85 were found in and around a large detonation hole. M85 duds were surface cleared from this locality, which is located in strike area CBU 519, during the emergency phase of operations. According to MACC SL Community Liaison Assistant Hassan Al Ali, not less than 17 M85 duds were removed from the surface of this and other gardens and olive groves around houses in the site CBU 519. Photo: Hassan Al Ali/MACC SL

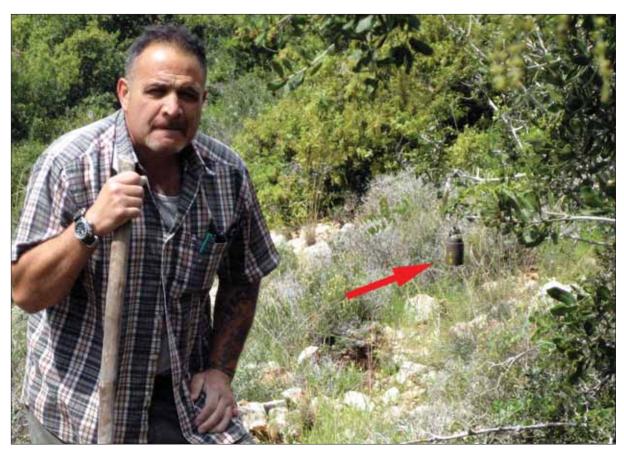
Figure 13: The bomblet ribbon can get caught on structures and vegetation. A fully armed bomblet hanging above the ground creates an extremely dangerous situation. This photo shows MACC SL Operations Officer Albert Philip next to an M42 bomblet, but the same problem occurs with M85 bomblets and all other DPICM. Photo: Hassan Al Ali/MACC SL.

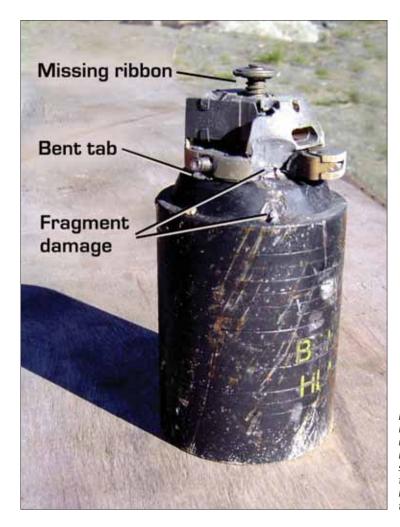
Figure 16: This dud bomblet from the Norwegian tests illustrates three of the major causes of failure. The ribbon has been torn off, excessive spin has caused the slide locking pin to bend over its retaining tab, allowing the spring to escape, and the bomblet has been damaged by fragments from nearby detonations. Photo: Colin King.

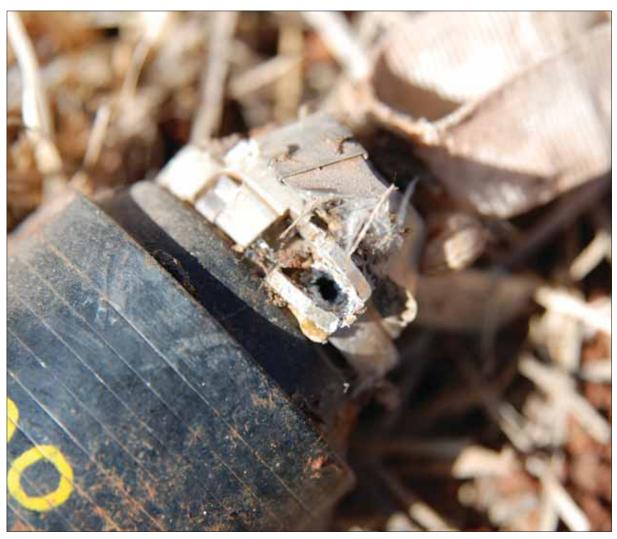
In some examples, bomblets appear to have armed and impacted correctly on hard, level ground yet failed to detonate. This indicates a probable failure of the detonator. In these unexploded bomblets, the SD back-up has also failed.

Figure 17: In some fuzes, the pyrotechnic SD delay had burned, but had not initiated the bomblet; this means that both the primary impact mechanism and the SD mechanism had failed. Photo: Amir Musanovic/NPA.

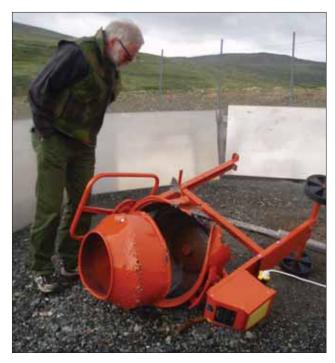
Figure 23:
Tests with
inert bomblets
have shown
that one hammer strike to
the body of an
M85 dud can
be sufficient to
make it arm.
Photo: Ove
Dullum/FFI.

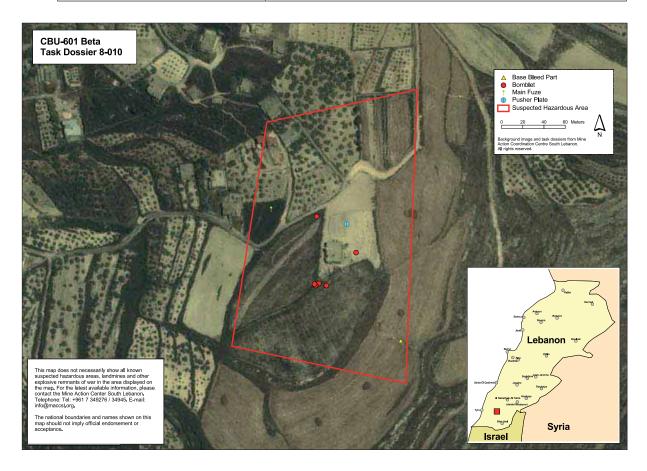
a)	Task dossier:	8-010
	CBU no.	601 Beta
	Location:	Bafliyah, Sur Middle District
	Status:	Surface and subsurface clearance finished and area released.
	No. of M85 duds found:	6 duds found (indications of at least 3 more)
	Failure rate analysis:	Inconclusive, but more than 1%

This area is covered with grass and olive trees. The research clearance team found six M85 duds, all of which were the result of normal deployment. Three of the duds were found buried, one at 4 cm and two at 2 cm. It seems that at least two duds had earlier been disposed of by Lebanese Armed Forces (LAF). A boy in the village was also said to have removed one dud and thrown it away at the village garbage point some 250 m away. Thus there are indications of three additional duds to those confirmed during research.

Indicators found in this area imply that not more than two projectiles were used. The research on this site was, however, not conclusive because of contradictory information about the degree to which other actors had removed duds, projectiles and other indicators. It was, therefore, not possible to draw firm conclusions about the numbers of projectiles.
