M85 An analysis of reliability

M85 - an analysis of reliability

This report presents a detailed analysis of M85 performance based on survey and clearance of M85 contaminated sites in southern Lebanon and on detailed analysis of M85 performance under test conditions, leading to the following conclusions:

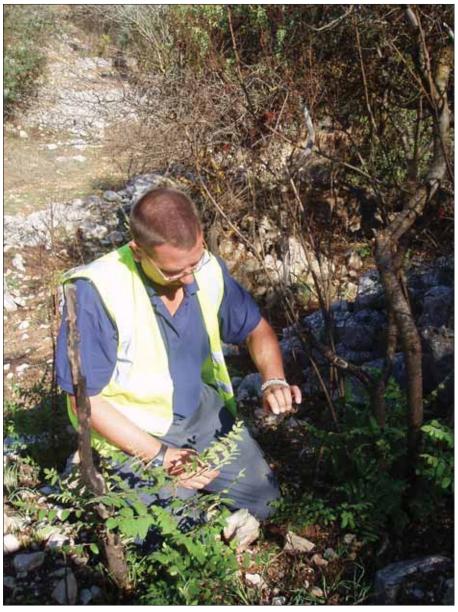
Simon Lovell, an EOD specialist from BACTEC, carefully examines an M85 dud at the site CBU 808 in Blida, South Lebanon. Photo: Ove Dullum/FFI

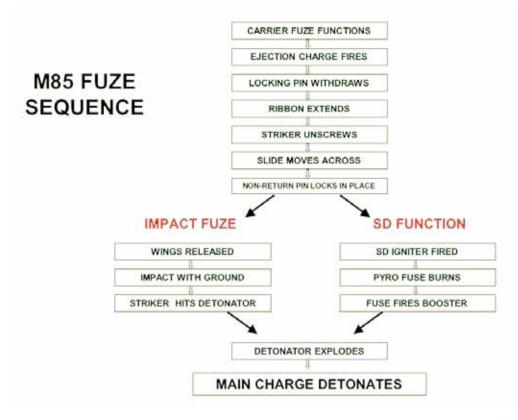
Figure 12: Summary of the M85 fuze sequence. It is important to note that the M85 is only capable of providing an additional level of reliability in certain instances of impact-fuze failure. If the arming sequence is stopped at any point, the bomblet will fail. Only when it is fully armed can either fuze (impact or SD) function.

- **Complexity:** the fuze incorporates a large number of components and required actions, resulting in many possible causes of failure. For each 'event' in the operating sequence (summarised in Figure 12), there are typically 3-5 things that can go wrong. ²⁸ Consequently, there are at least 20 possible causes of failure during the arming sequence before the two fuzing systems (impact and SD) become operative, and a further number that might prevent each of them from functioning correctly.

There are many reasons why the sequence shown in Figure 12 may be interrupted, causing the M85 bomblet to fail.

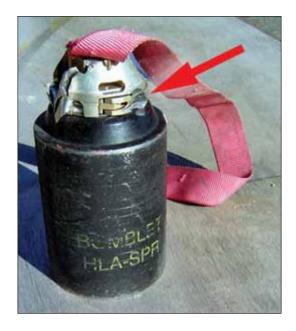
Figure 14: The separation process. Source: Presentation by Mark Hiebel; XM242 Pyrotechnic Self Destruct Fuze for 155 mm XM864E2 Recap; 51st Annual Fuze Conf., Nashville, TN, 2007

This effect often leads to scratching or deformation of the fuze body. Whenever this damage affects the slot housing the slide, the opening will most likely be crimped and the slide stuck inside the housing,³⁰ thus preventing the bomblet from arming; this can be seen in Figure 14. The higher the spin rate, the

greater the forces acting on the bomblets³¹ and the more likely they are to sustain this damage during ejection. Two possible ways in which the fuze can be damaged during the ejection and separation of bomblets are illustrated in Annex H.

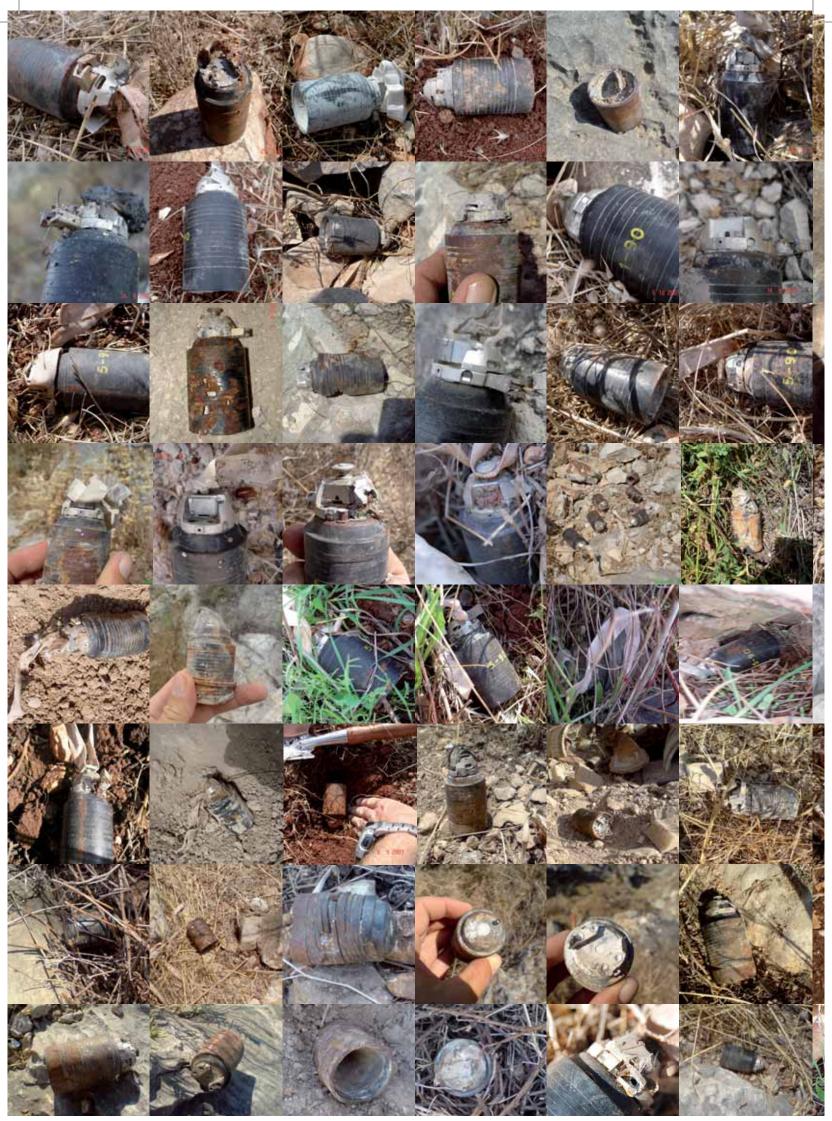
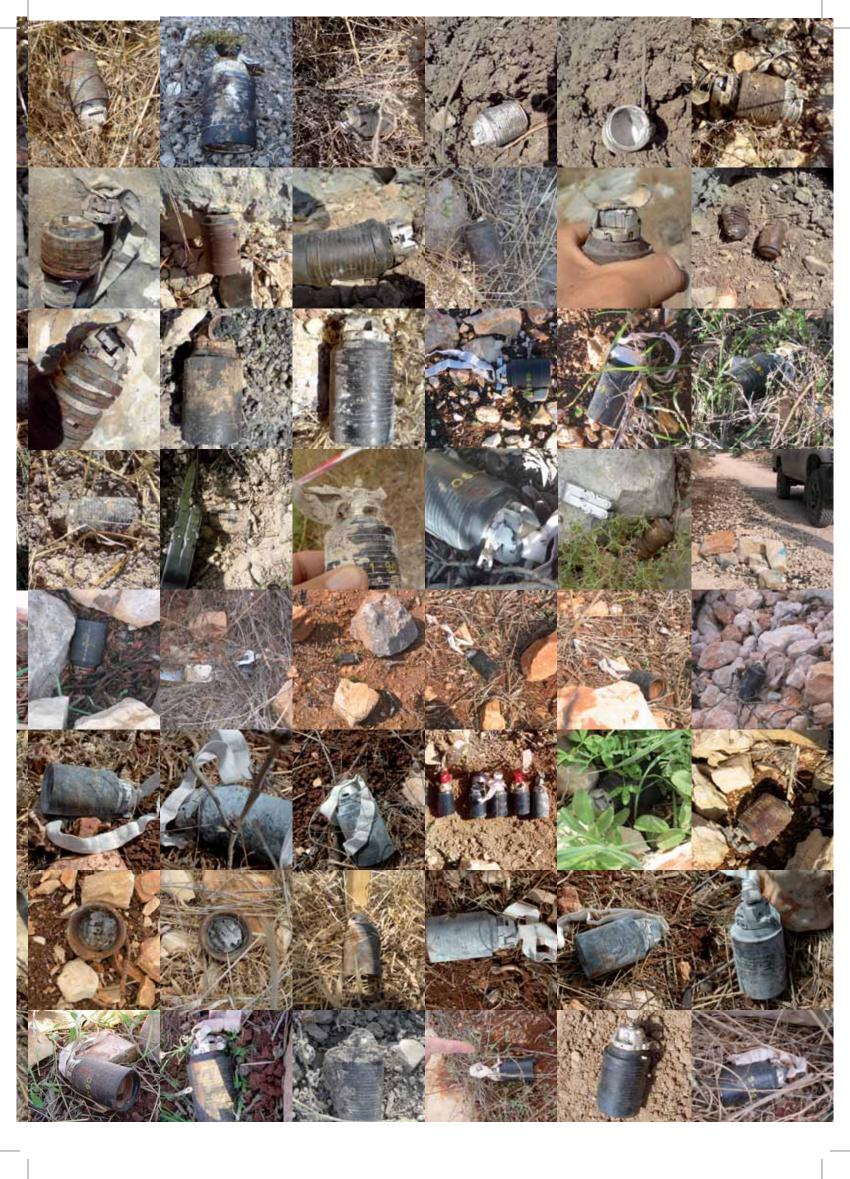
These two pages show individual M85 duds found in Southern Lebanon.
